TEST REPORT

No. : XMIN2203002377CM

Sample Name : EPC
Material and Mark : PVC
Other Information : Type No.: MOAB8
Colour: Wood
Density: 8.9 kg/m²
Thickness: 6.5/0.5
Samples size: 9" * 56"
Intended Use: Flooring

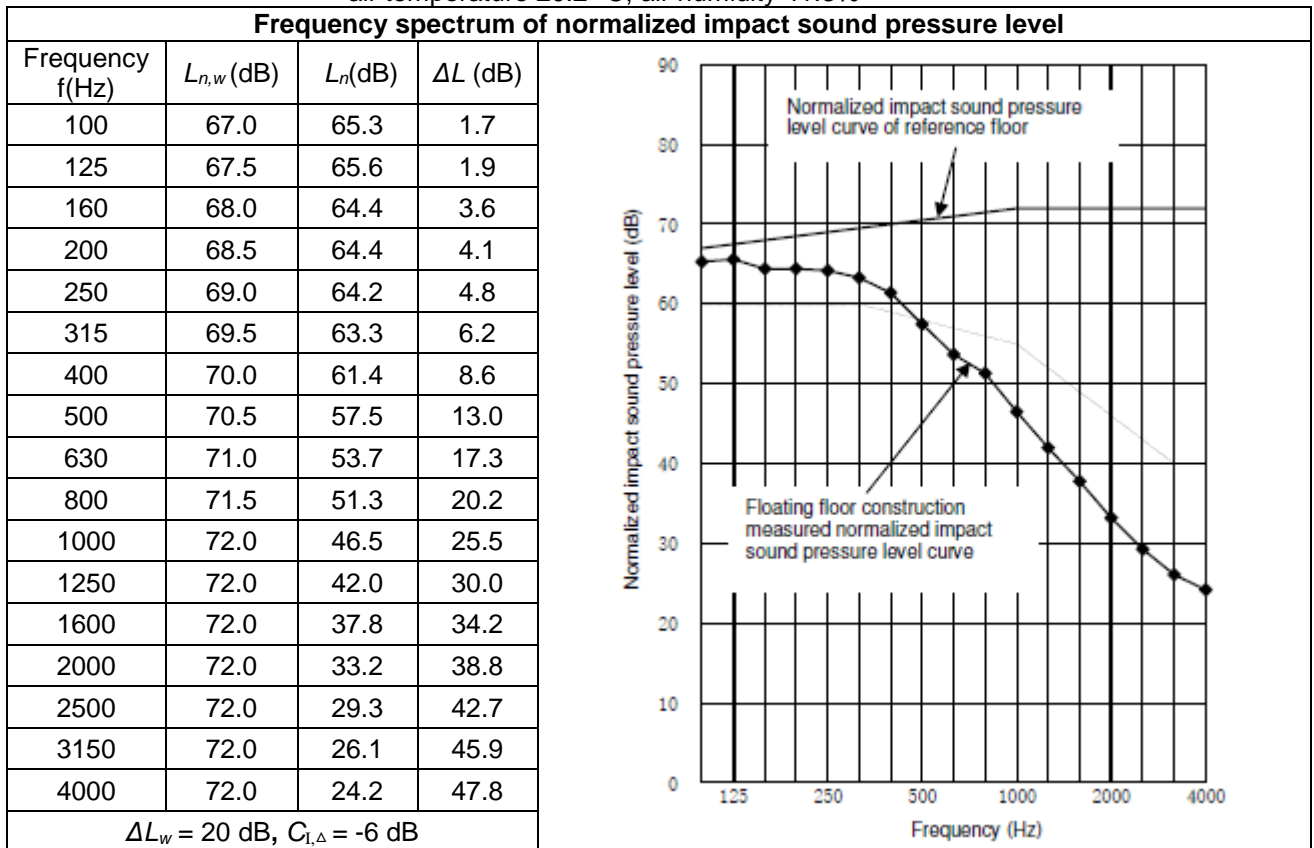
- Sample Description : Flooring (see the photo)
Total Thickness:6.5mm, surface density: about 8.9 kg/m²
- Test conducted : ISO 10140-1:2021, ISO 717-2:2020
- Project description : No decoration of sample surface and installation assembled directly.
The test specimen was covered on a 150mm concrete floor, testing area 11.3m²
- Test Equipment : RTA840 system
- Test Environment : Source room volume 125m³, receiving room volume 100m³,
air temperature 20.2 °C, air humidity 41.3%

1. $L_{n,w}$ as the weighted normalized impact sound pressure level
2. L_n as the measured normalized impact sound pressure level
3. The above test project/method was carried out by subcontractors.

No.	Test Item	Test Method	Result
1	Improvement of impact sound insulation	ISO 10140-1:2021 ISO 717-2:2020	$\Delta L_w = 20$ dB
